# Stillwater County

## 2008 Capital Improvements Program

**FINAL DRAFT**

**January 2008**

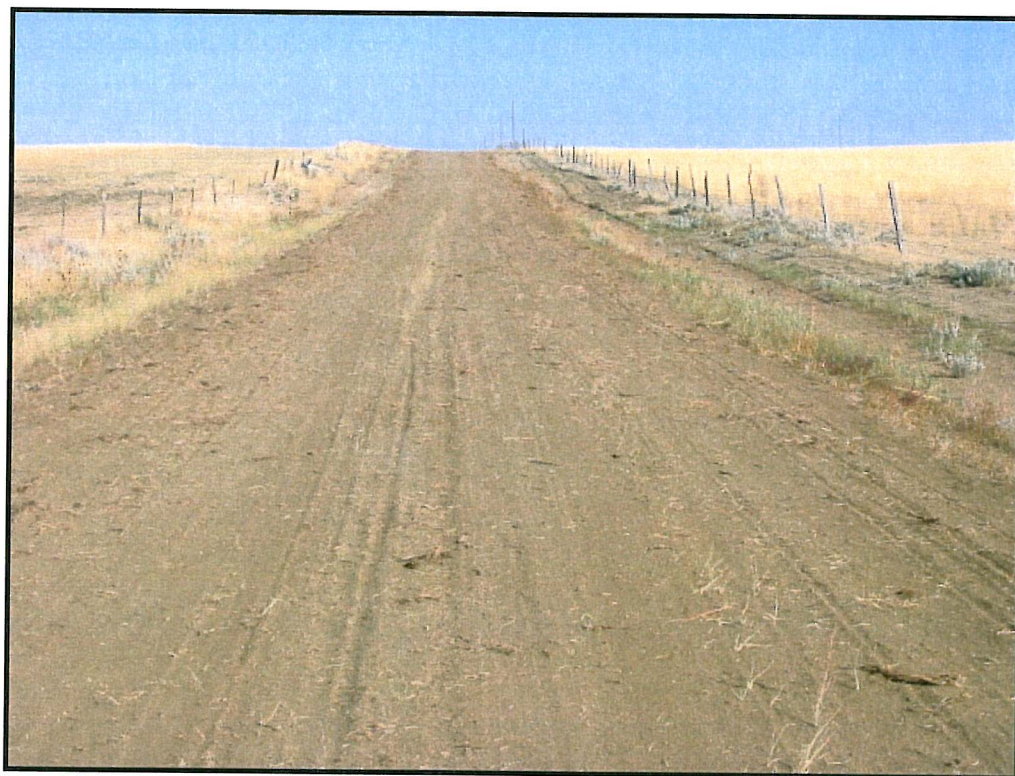
Figure 1: Roadway with no gravel

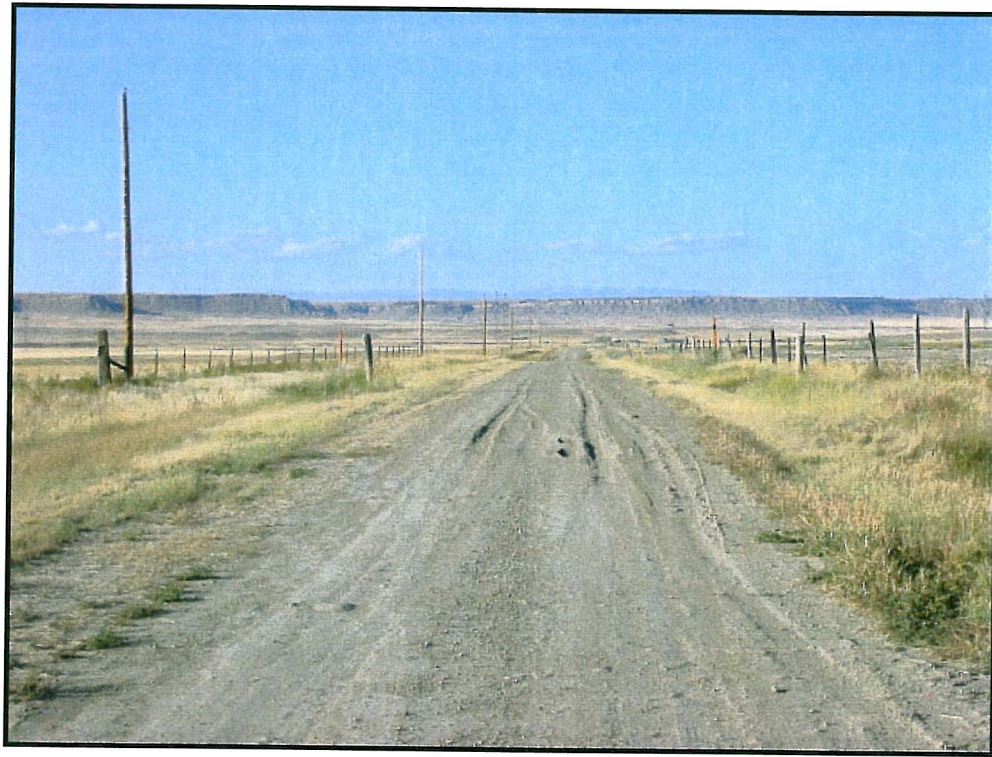
Figure 2: Poor drainage and failed crown

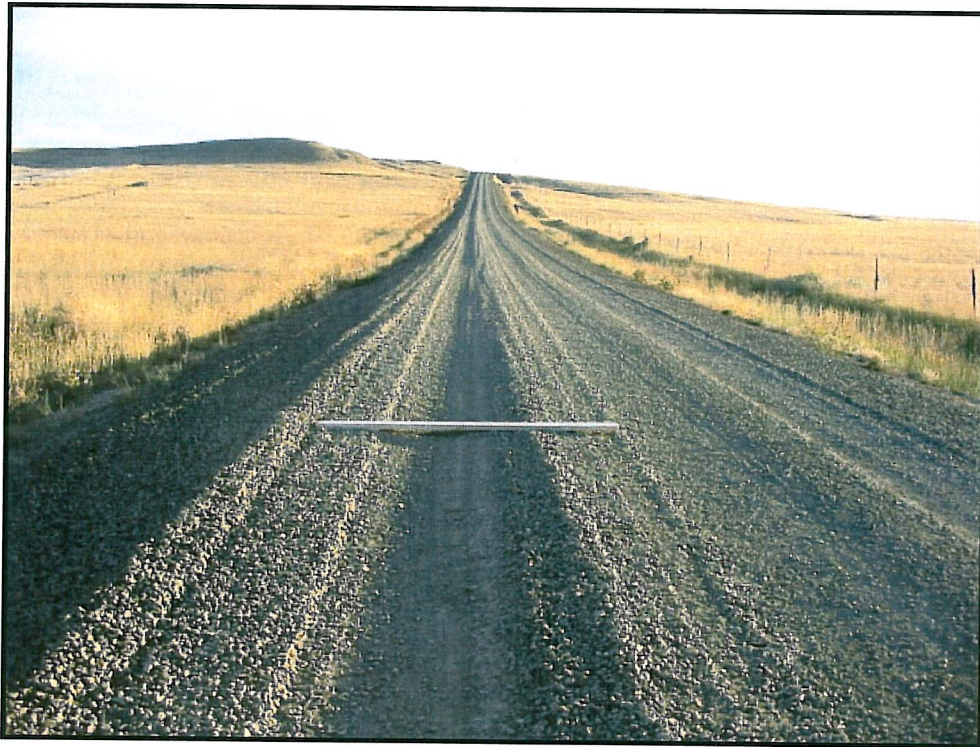
few roads that have defects, but most of them can be fixed by improving the crown or by mixing additional gravel into the road surfacing. The one defect that showed up the most was rutting (See Figure 3). Most roads had some rutting which is a common problem with gravel roads with no gravel layer for a riding surface. Without a good gravel layer there is nothing to support the traffic loading which results in ruts forming in the driving paths. There are a few roads that had severe rutting which will take a major surface reconstruction to correct.

Figure 3: Big Coulee Rd. (Rutting and Loose Aggregate)

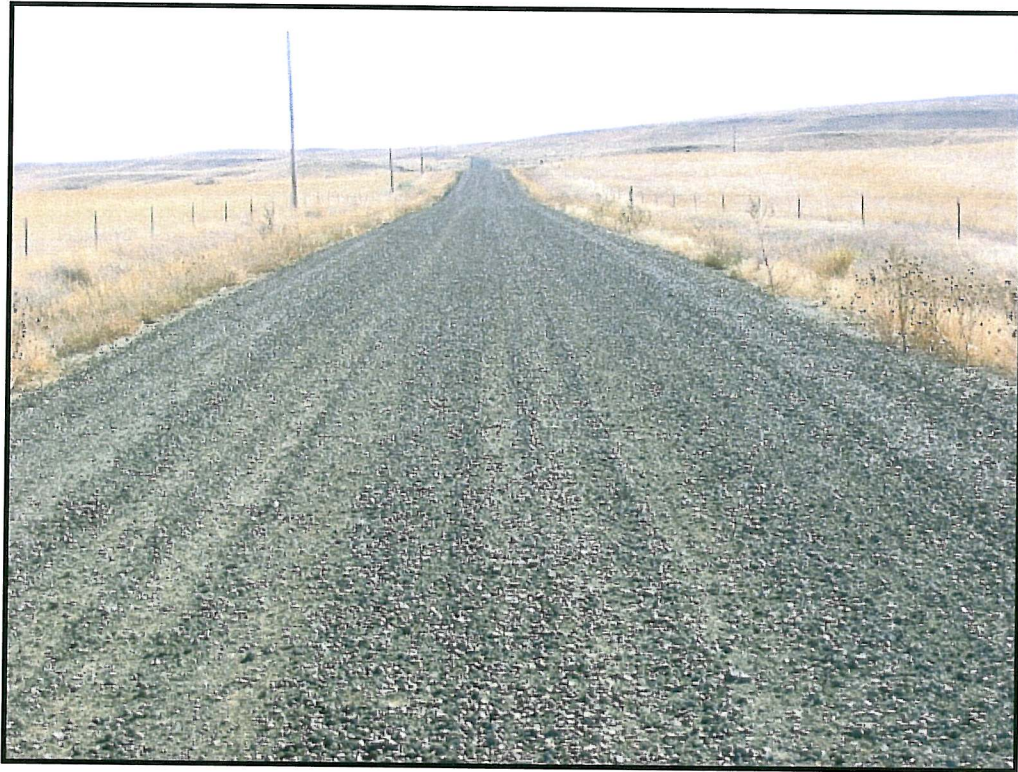
Figure 4: Flat Rd. (PASER Rating of 4)

The recommendation on roads with a PASER Rating of a 5 is to perform no maintenance. With the roads receiving a PASER Rating of 4 (See Figure 4) the first recommendation is to review the field notes and the PASER Rating print outs to determine what deficiencies caused a road rating of 4 and determine what maintenance the road needs if any. Roads with a 4 rating may need routine maintenance or drainage repairs in select spots, but for the most part are good roads and little to no maintenance is required.

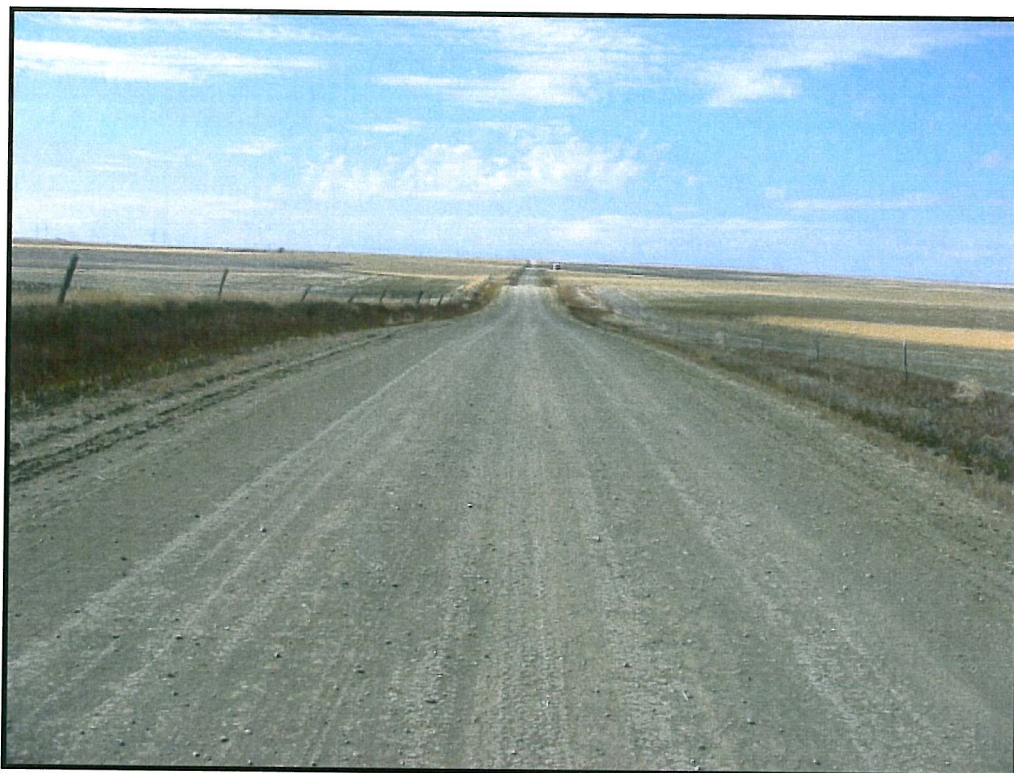
Figure 5: PASER Rating of 3

A road rating of 3 is a fair road that does need maintenance performed on it before the road deteriorates to a rating of 2. Roads with a higher ranking of 3 may just need to be scarified and thoroughly mixed then re-graded to reestablish the road crown and to remove potholes or washboarding (See Figure 5). Most of the roads with a rating of 3 had little to no gravel layer or crown and need to be re-graded and have gravel material added to the road surfacing, or need ditch improvements, or culvert maintenance performed.

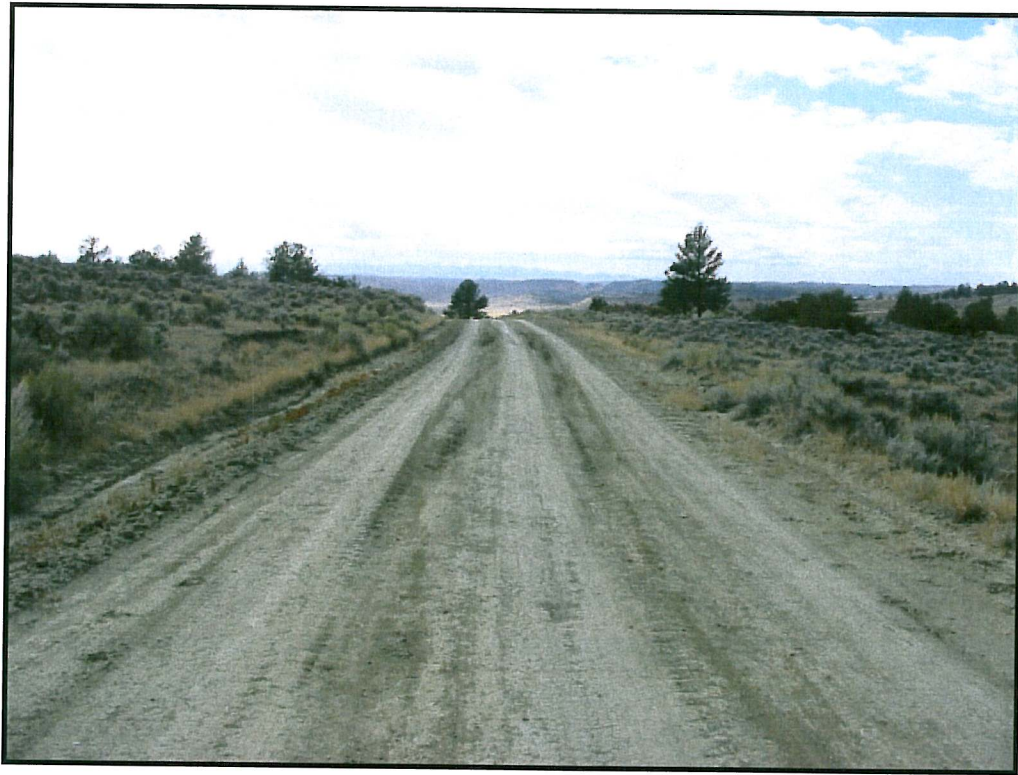
Figure 6: A Section of Sheep Dip Road. (PASER Rating of 1)

A road with a rating of 1 (See Figure 6) is ranked as a failed road and maybe closed to the public at times. A roadway with a failed ranking will need to be completely reconstructed with ditches and possibly new culverts at appropriate locations.
